MISCELLANEOUS PAPER SL-80-19

CONCRETE DETERIORATION  
IN SPILLWAY WARM-WATER CHUTE  
RAYSTOWN DAM, PENNSYLVANIA

December 1980

Final Report

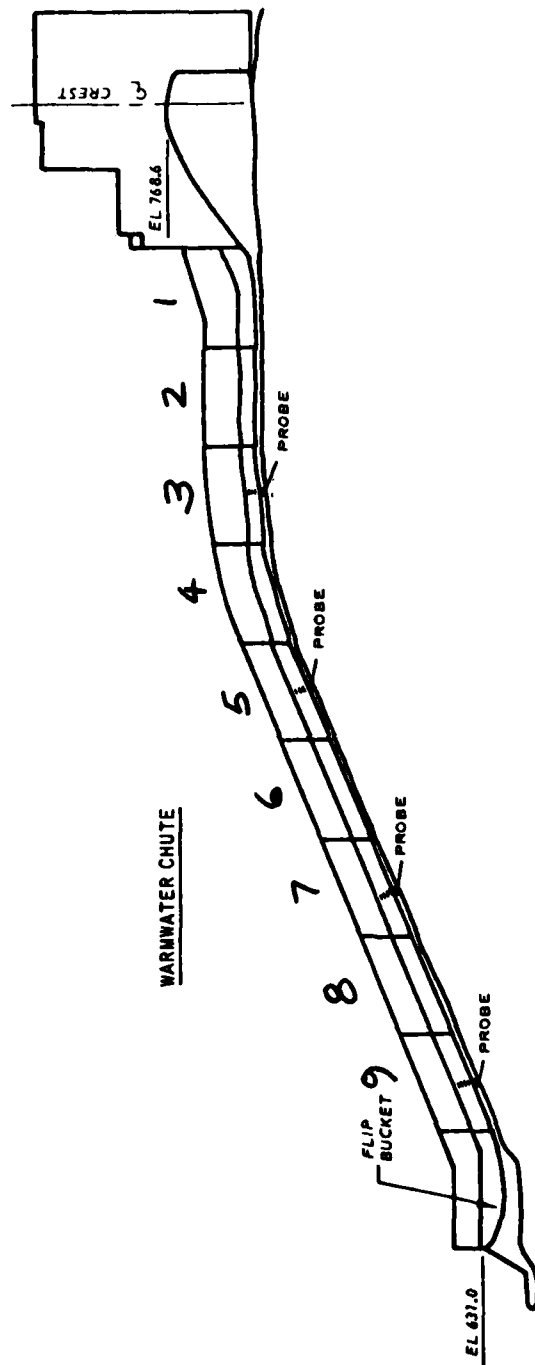
Figure 8. Schematic showing numbering of monoliths referred to in Table 2  
(from Fagerburg, 1979)
